TWR-64392  
ECS #: SS5116

## Case Inner Diameter "Spider" Pitting Investigation, Process Simulation Article (PSA), Final Test Report

5-Nov-1993

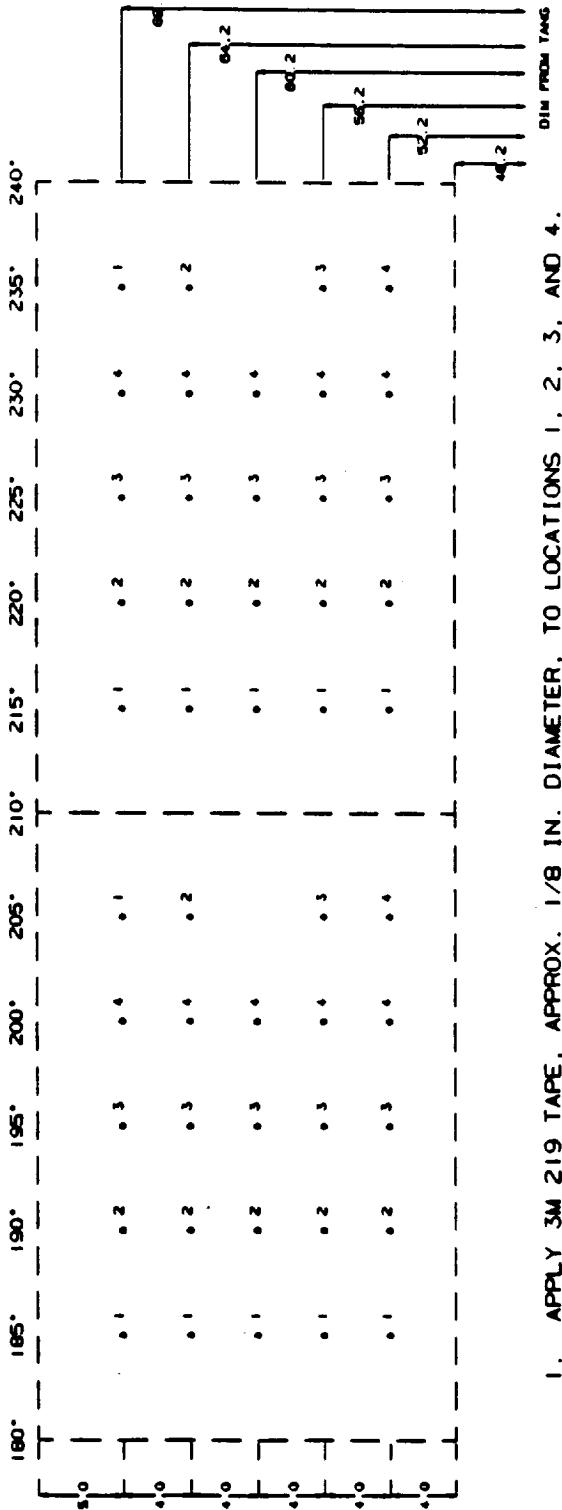
SPIIDER PITTING TEST (CHEMLOK APPLICATION)

1. APPLY 3M 219 TAPE, APPROX. 1/8 IN. DIAMETER, TO LOCATIONS 1, 2, 3, AND 4.
2. APPLY CHEMLOK 205 PRIMER.
3. REMOVE TAPE FROM LOCATIONS 1 AND 3 ONLY.
4. APPLY CHEMLOK 233 ADHESIVE.
5. REMOVE TAPE FROM LOCATIONS 2 AND 4.

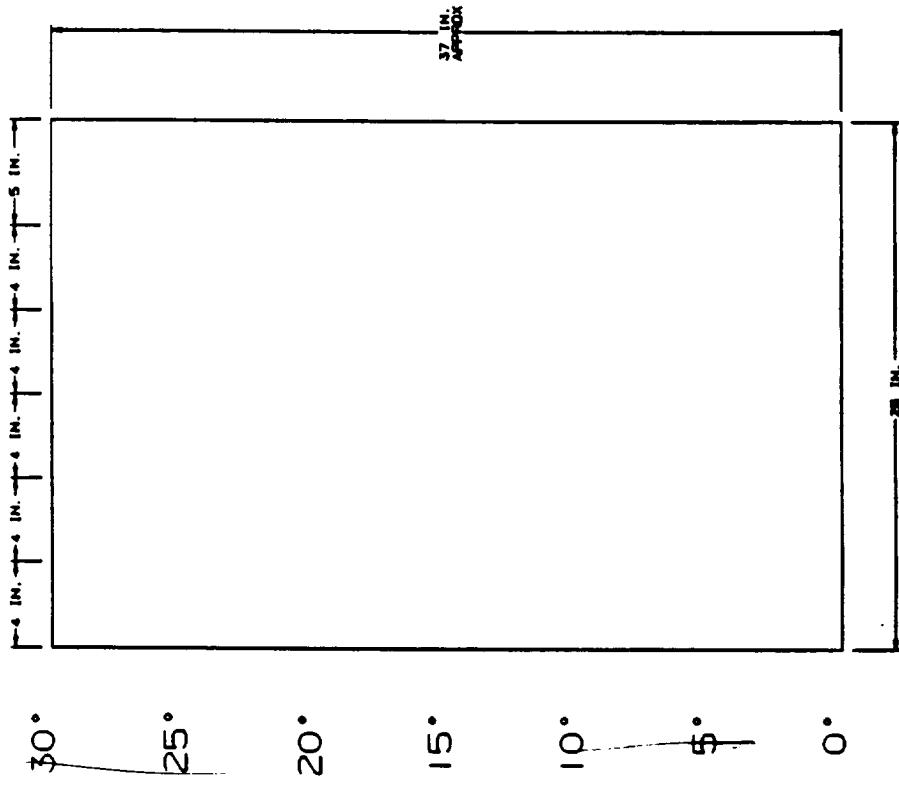
TEST AREA # 1

1. APPLY BOTH PLYS OF NBR ACTIVATED WITH TCA.

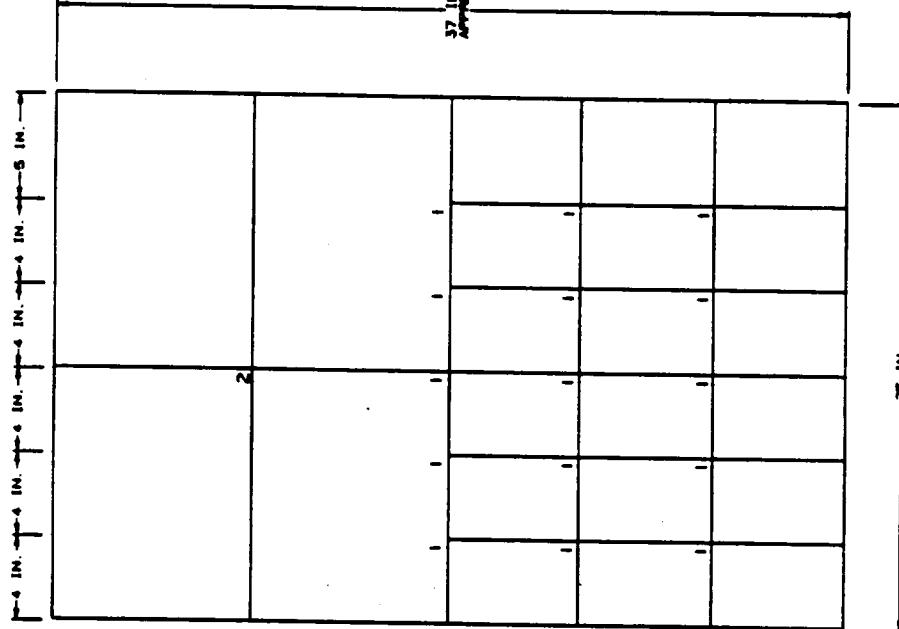
## TEST AREA # 2

1. APPLY FIRST PLY OF NBR ACTIVATED WITH TCA.
2. INJECT TCA BETWEEN NBR CHEMLOK.
3. A. 15 cc OF TCA AT LOC. 1 holes  
B. 15 cc OF TCA AT LOC. 2 inject  
3. APPLY SECOND PLY OF NBR ACTIVATED WITH TCA.

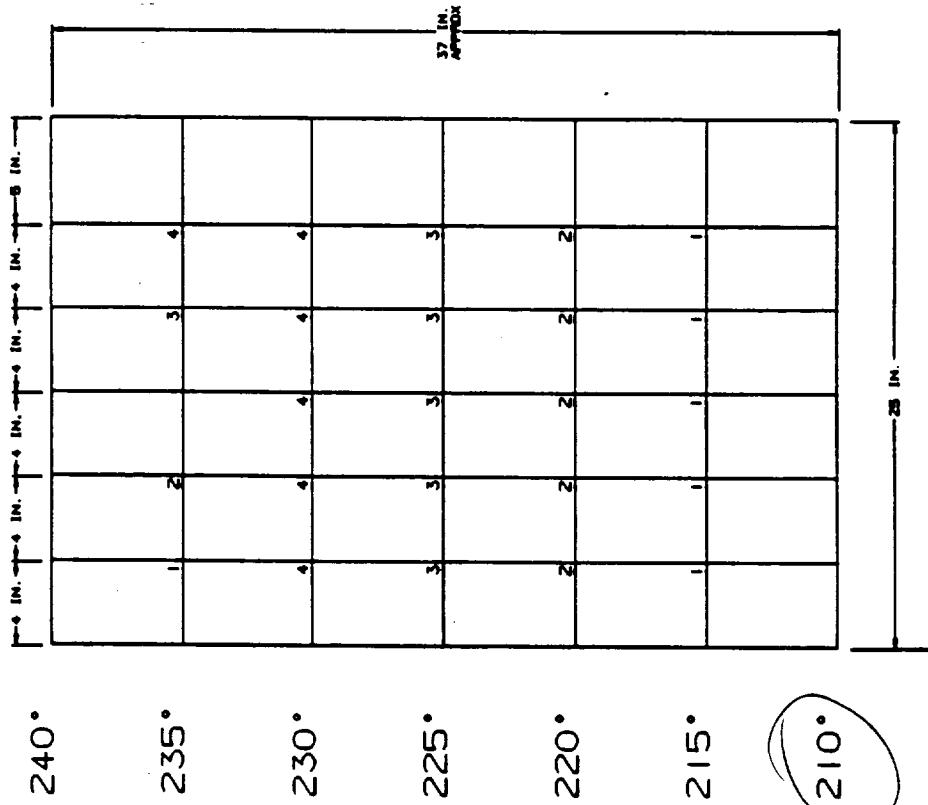
TEST AREA # 8

1. APPLY A SMALL PINCH OF WATER SATURATED ASBESTOS AT LOC 1, 2, 3, AND 4.
2. APPLY FIRST PLY OF NBR ACTIVATED WITH TCA.
3. APPLY SECOND PLY OF NBR ACTIVATED WITH TCA.

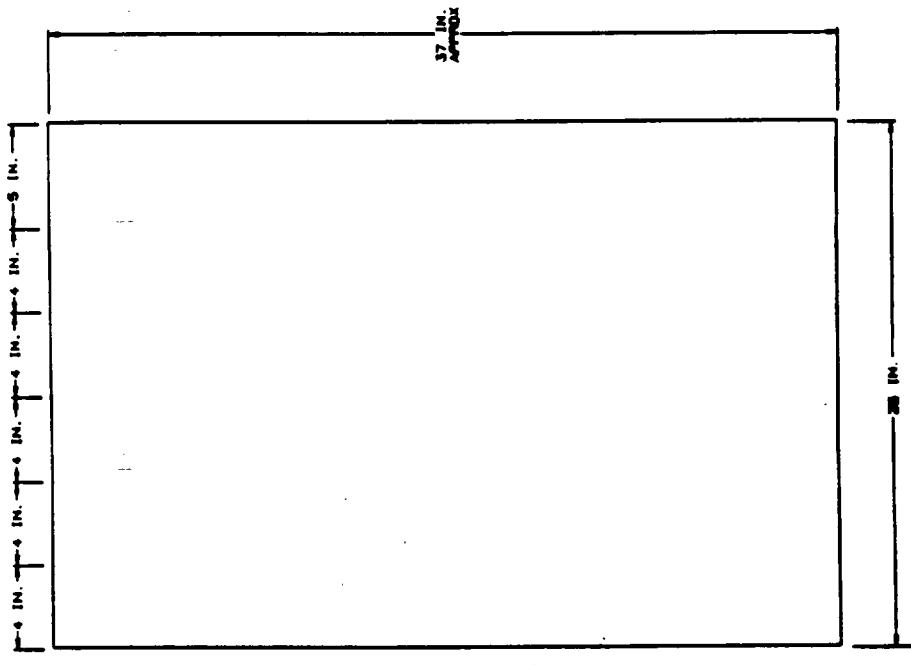
TEST AREA # 9

1. APPLY FIRST PLY OF NBR ACTIVATED WITH TCA.
2. AFTER 15 SECONDS REMOVE NBR FROM CHEMLOK. EXAMINE CHEMLOK FOR DEFECTS.
  - A. EXAMINE CHEMLOK FOR DEFECT LOCATIONS.
  - B. DOCUMENT DEFECT ON THIS SKETCH.
  - C. IF NO DEFECTS WERE CREATED RETRY STEPS 1 AND 2, VARYING TIMES OF NBR ADHESION.
  - D. REAPPLY FIRST PLY OF NBR ACTIVATED WITH TCA.
3. APPLY SECOND PLY OF NBR ACTIVATED WITH TCA.

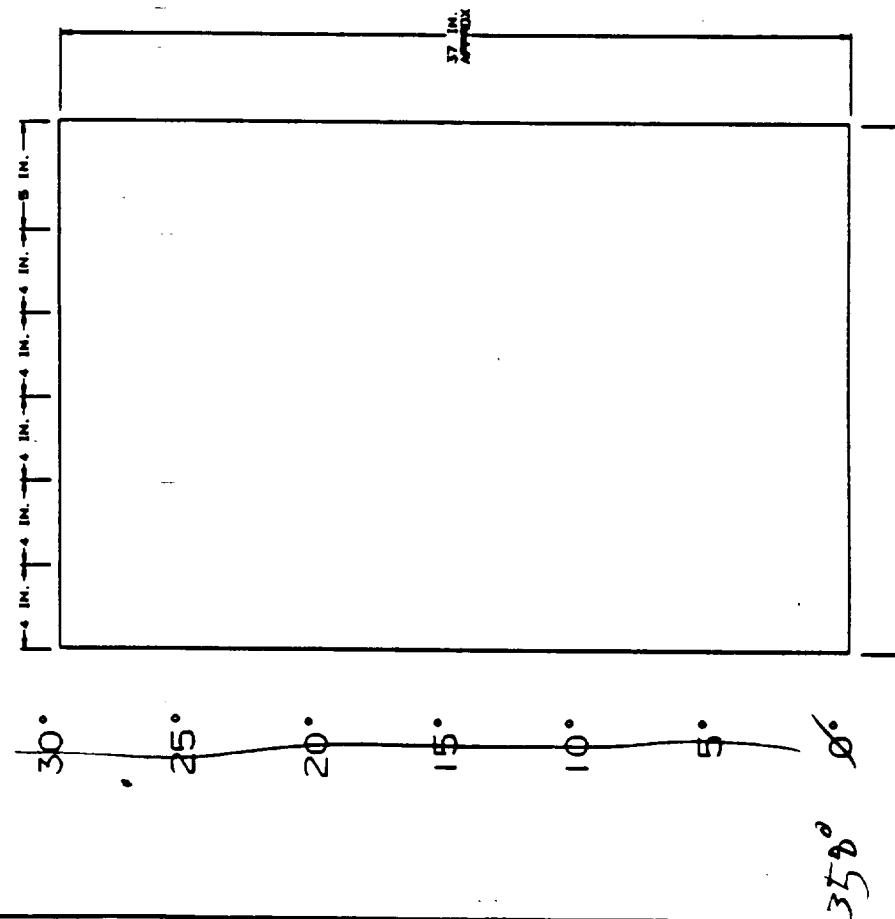
TEST AREA # 13

1. APPLY BOTH PLYS OF NBR ACTIVATED WITH TCA.

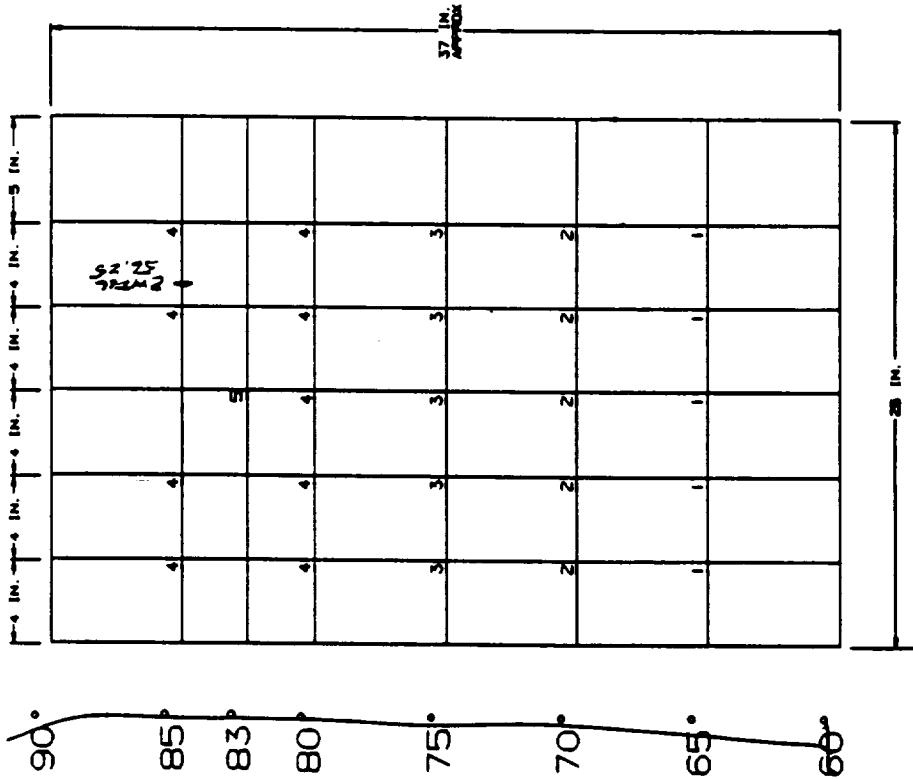
TEST AREA # 15

1. APPLY A SMALL PINCH OF WATER SATURATED ASBESTOS AT LOC 1, 2, 3, AND 4.
  2. APPLY FIRST PLY OF NBR ACTIVATED WITH TCA.
  3. INJECT TCA BETWEEN NBR AND CHEMLOK.
  4. ~~APPLY A 1/2 CC OF TCA AT LOC 1, 2, 3, 4, 5. BESIDES 1/2 CC OF TCA AT LOC 5.~~  
APPLY SECOND PLY OF NBR ACTIVATED WITH TCA.

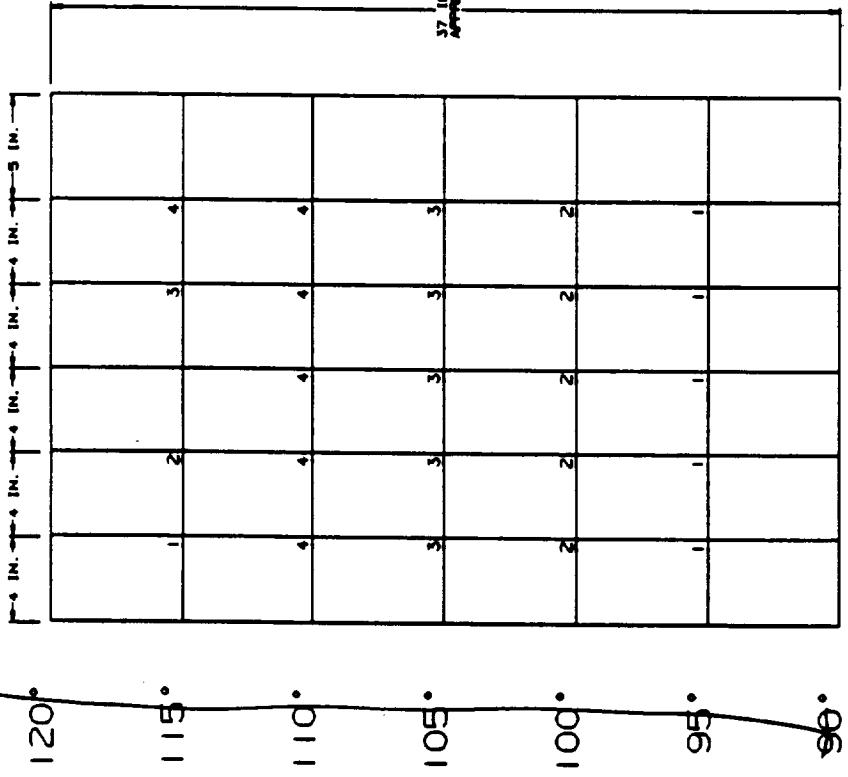
TEST AREA # 16

1. APPLY A SMALL PINCH OF WATER SATURATED ASBESTOS AT LOC 1, 2, 3 AND 4.
2. APPLY FIRST PLY OF NBR ACTIVATED WITH TCA. INJECT TCA/WATER BETWEEN NBR AND CHEMLOK holes A..1 cc OF (0.000) TCA) AT LOC 1.
3. holes B..1 cc OF (0.001) TCA) AT LOC 2.
- holes C..1 cc OF (0.01) TCA) AT LOC 3.
- holes D..1 cc OF (0.1) TCA) AT LOC 4.
4. APPLY SECOND PLY OF NBR ACTIVATED WITH TCA.

\* No additional water added (water was in the asbestos string sample)

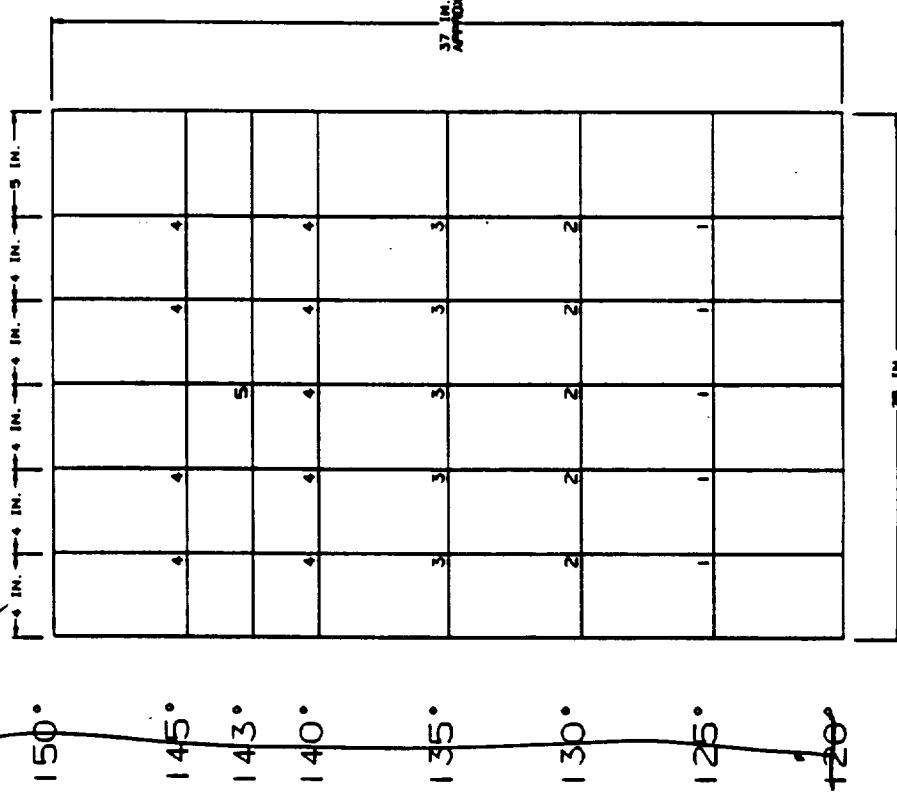
TEST AREA # 17

1. APPLY A SMALL PINCH OF WATER SATURATED ASBESTOS AT LOC 1, 2, 3 AND 4.
  2. APPLY FIRST PLY OF NBR ACTIVATED WITH TCA.
  3. AFTER 15 SECONDS, REMOVE NBR FROM CHEMLOK.
  - A. EXAMINE CHEMLOK FOR DEFECTS.
  - B. DOCUMENT DEFECTS ON SKETCH.
  - C. IF NO DEFECTS ARE CREATED, RETRY STEPS 2 AND 3 VARYING TIMES OF NBR ADHESION.
  - D. REAPPLY FIRST PLY OF NBR ACTIVATED WITH TCA.
  4. INJECT TCA BETWEEN NBR AND CHEMLOK. ADJUST INJECTION POINT TO CORRESPOND WITH DEFECTS DOCUMENTED IN STEP 3.
- hole A: 1 c.c. OF TCA AT LOC 1, 2 AND 3.  
hole B: 0.5 c.c. OF TCA AT LOC 5.*
5. APPLY SECOND LAYER OF NBR ACTIVATED WITH TCA.

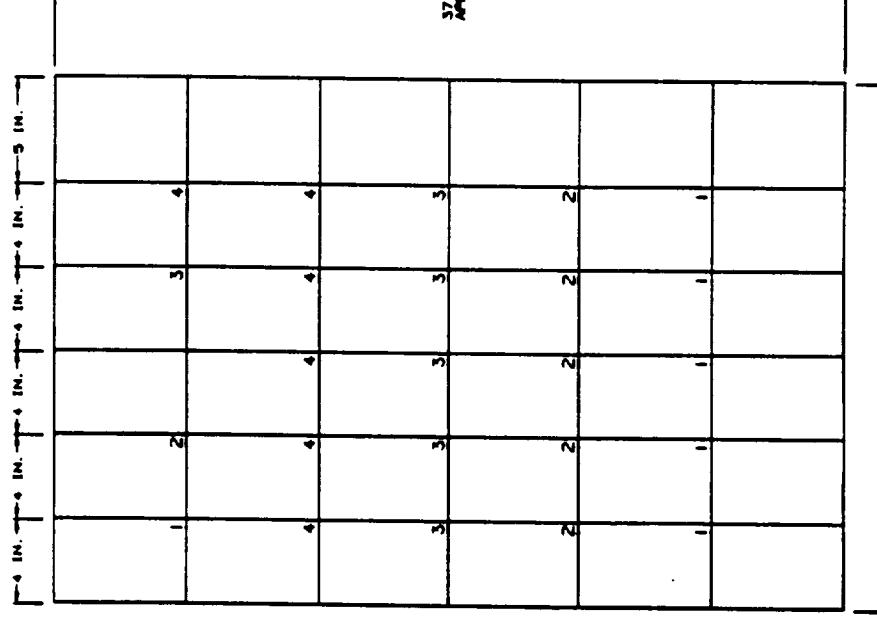
TEST AREA # 18

1. APPLY A SMALL PINCH OF WATER SATURATED ASBESTOS AT LOC 1, 2, 3, AND 4.
2. APPLY FIRST PLY OF NBR ACTIVATED WITH TCA.
3. AFTER 15 SECONDS, REMOVE NBR FROM CHEMLOK.
4. EXAMINE CHEMLOK FOR DEFECTS.
5. DOCUMENT DEFECTS ON SKETCH.
6. IF NO DEFECTS ARE CREATED, RETRY STEPS 1 AND 2 VARYING TIMES OF NBR ADHESION.
7. REAPPLY FIRST PLY OF NBR ACTIVATED WITH TCA.
8. INJECT TCA/WATER BETWEEN NBR AND CHEMLOK. ADJUST INJECTION POINT TO CORRESPOND WITH DEFECTS DOCUMENTED IN STEP 3.

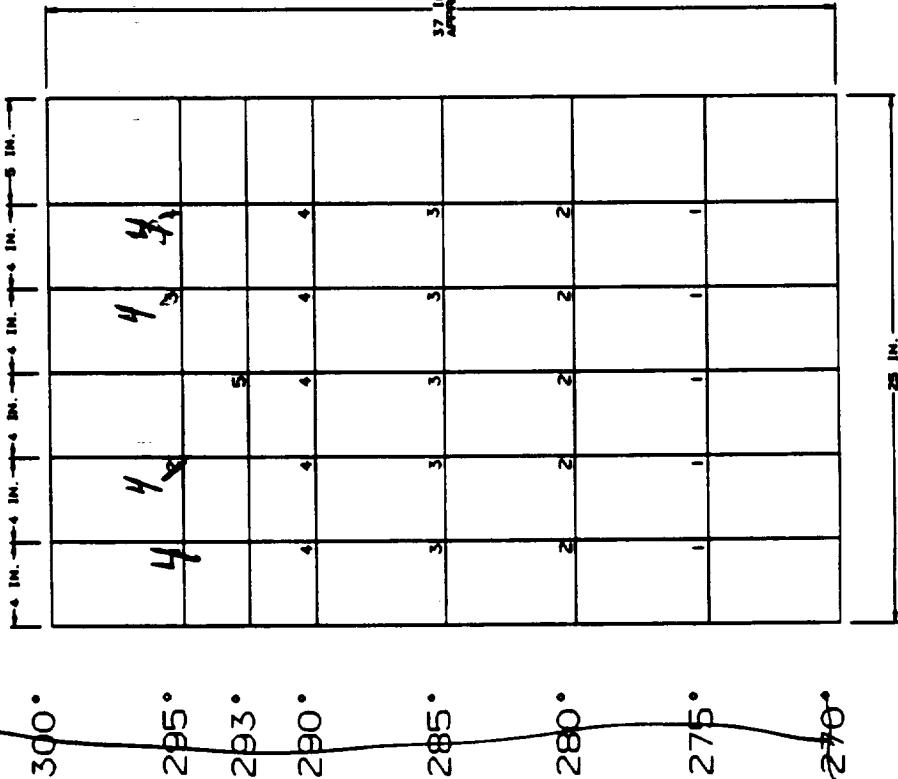
TEST AREA # 22

1. APPLY FIRST PLY OF NBR ACTIVATED WITH TCA.
  2. AFTER 15 SECONDS, REMOVE NBR FROM CHEMLOK.
    - A. EXAMINE CHEMLOK FOR DEFECTS.
    - B. DOCUMENT DEFECTS ON SKETCH.
    - C. IF NO DEFECTS ARE CREATED, RETRY STEPS 1 AND 2 VARYING TIMES OF NBR ADHESION.
    - D. REAPPLY FIRST PLY OF NBR ACTIVATED WITH TCA.
  3. INJECT 1 cc OF SIMULATED SWEAT (ASTM D-1141 SUB OCEAN WATER PH ADJUSTED TO 5.0±0.5 WITH HCL) AT LOC 1 AND 3.
  4. INJECT TCA/WATER BETWEEN NBR AND CHEMLOK. ADJUST INJECTION POINT TO CORRESPOND WITH DEFECTS DOCUMENTED IN STEP 2.
    - A. 1 cc OF (0.001) WATER : TCA) AT LOC 1.
    - B. 1 cc OF (0.001) WATER : TCA) AT LOC 2.
    - C. 1 cc OF (0.001) WATER : TCA) AT LOC 3.
    - D. 1 cc OF (0.001) WATER : TCA) AT LOC 4.
  5. APPLY SECOND LAYER OF NBR ACTIVATED WITH TCA.

After cure, the insulation was noted to be blackened where methyl chloroform was added under the insulation. Two large discolored bubbles were noted at test areas 22 and 34. Test area 22 at the location of the bubble was injected with 2.5 milliliters of methyl chloroform and 2.5 milliliters of ASTM D-1141 ocean water with the Ph adjusted to  $5.0 \pm 0.5$ . Test area 34 at the location of the bubble was injected with 2.5 milliliters of methyl chloroform and 2.5 milliliters of water. Figure 2 shows test area 22 with the large discolored bubble in the insulation. Engineering and project engineering agreed to modify the test plan by taking a sample of the gas under the bubble in test area 22. Adjacent insulation was cut around the bubble, a sample of the metal surface residue was taken and analyzed. The bubble in test area 34 was left as a control. The gas from the bubble was a hydrogen gas / air mixture. When the bubble in test area 22 was removed a line of deep narrow pits 1.2 inch long by 2/32 inches wide by 0.0110 inch deep, were discovered and sampled. Material removed from the pits was determined to be Chemlok®. Figure 1 shows the line of pits after insulation washout. When the pits were reexamined after insulation washout it was determined that the pits did not grow.

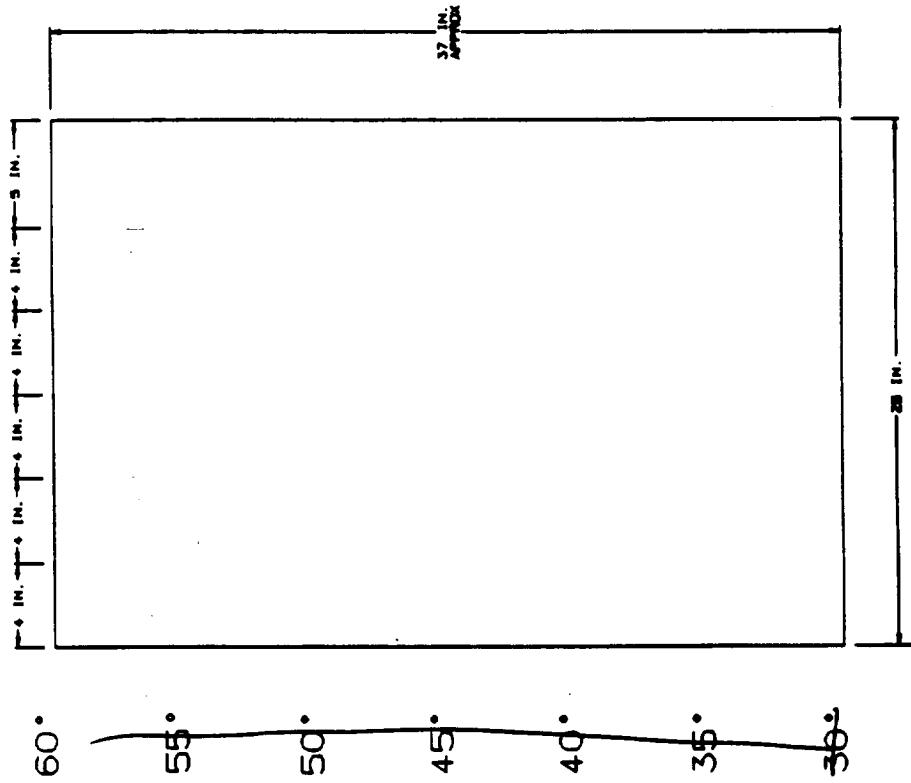
TEST AREA # 26

1. APPLY BOTH PLYS OF NBR  
ACTIVATED WITH TCA.

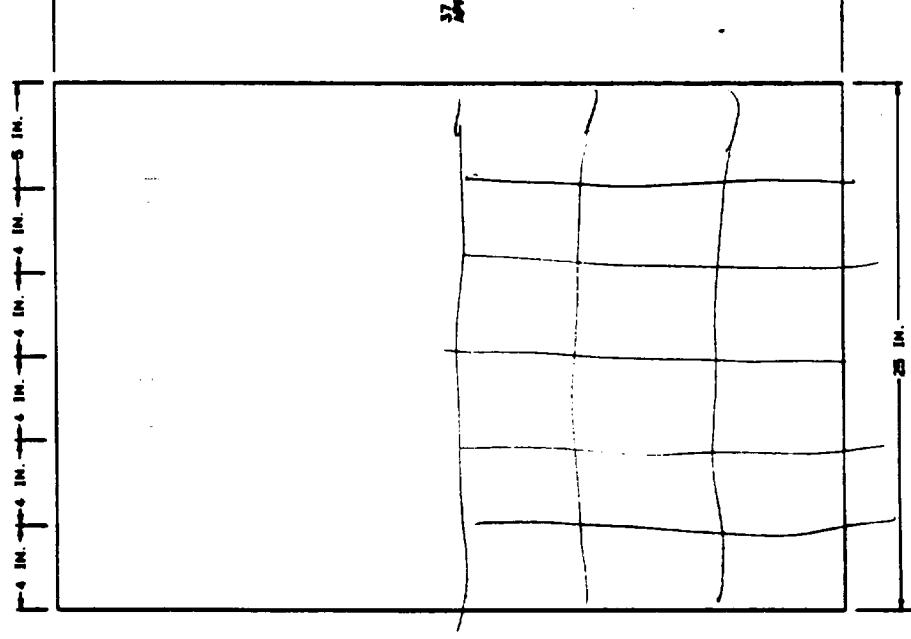
TEST AREA # 33

1. APPLY BOTH PLYS OF NBR  
ACTIVATED WITH MEK

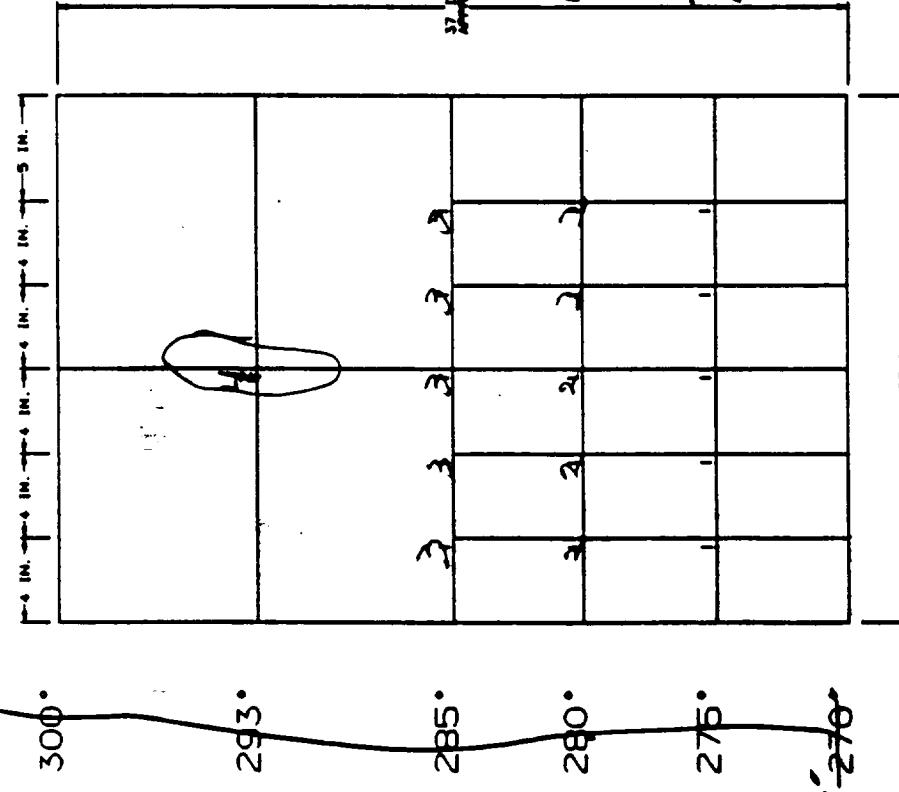
TEST AREA # 34

1. APPLY FIRST PLY OF NBR ACTIVATED WITH TCA.
2. INJECT TCA/WATER BETWEEN NBR AND CHEMLOK.  
5 cc OF (0.01 WATER :  
1 TCA) AT LOC 1  
20 cc OF (0.01 WATER :  
1 TCA) AT LOC 2.
3. APPLY SECOND PLY OF NBR ACTIVATED WITH TCA.

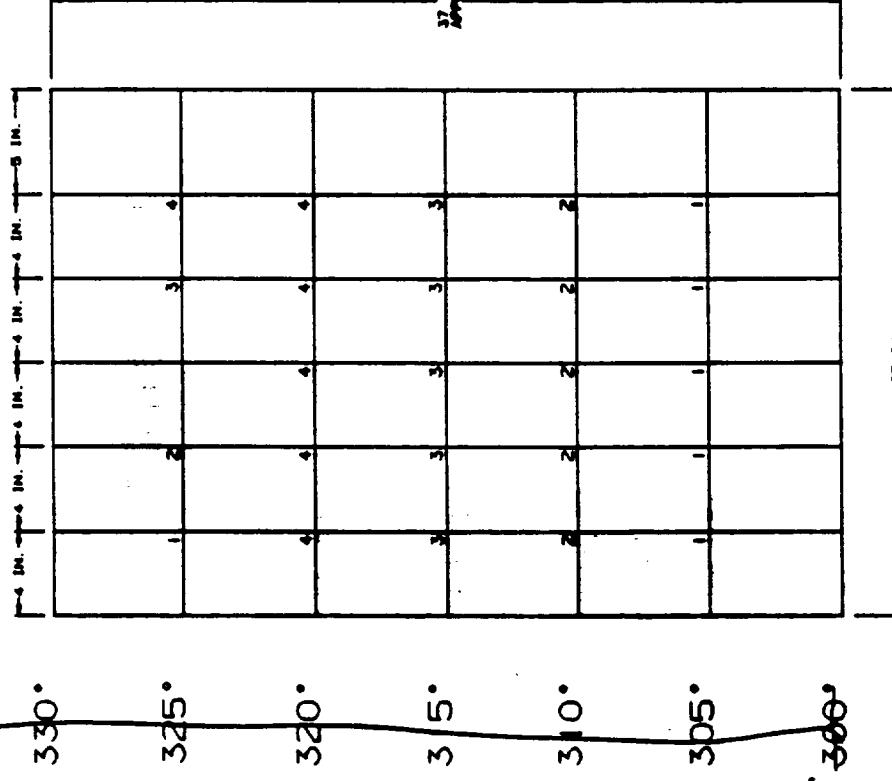
## TEST AREA # 35

1. APPLY FIRST PLY OF NBR ACTIVATED WITH TCA.
2. AFTER 15 SECONDS, REMOVE NBR FROM CHEMLOK FOR DEFECTS.
  - A: EXAMINE CHEMLOK ON SKETCH.
  - B: DOCUMENT DEFECTS ARE CREATED.
  - C: IF NO DEFECTS ARE CREATED, RETRY STEPS 1 AND 2 VARYING TIMES OF NBR ADHESION.
  - D: REAPPLY FIRST PLY OF NBR ACTIVATED WITH TCA.
3. INJECT TCA/WATER BETWEEN NBR AND CHEMLOK. ADJUST INJECTION POINT TO CORRESPOND WITH holes DOCUMENTED IN STEP 2.  
*(4234A)*
4. APPLY SECOND LAYER OF NBR ACTIVATED WITH TCA.

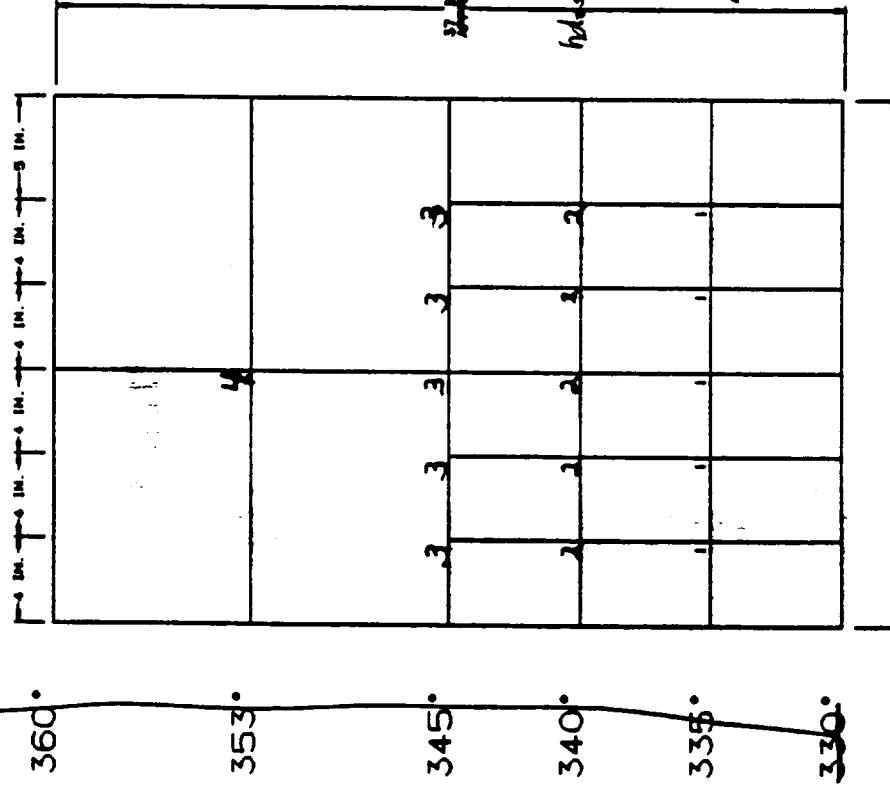
TEST AREA # 36

1. APPLY FIRST PLY OF NBR ACTIVATED WITH TCA.
  2. INJECT TCA BETWEEN NBR AND CHEMLOK.
  3.
